REPORT OF AIR FORCE AIRCRAFT ACCIDENT

1. GENERAL INFORMATION																																		
1. PLACE OF ACCIDENT (State, county, nearest town, or distance and direction from nearest town. If accident occurred on airport identify.) Texas, Glasscock Co, 19 NM SW of Sterling City, Texas; 15 NM SE of Garden City, Texas.

15. AIRCRAFT NUMBER			16. TYPE, MODEL, SERIES AND BLOCK NUMBER				17. ASGMT AND STATUS CODE AT TIME OF ACCIDENT (See AFR 65-110)																											
52-2818A			B-36J-5-CF				CC

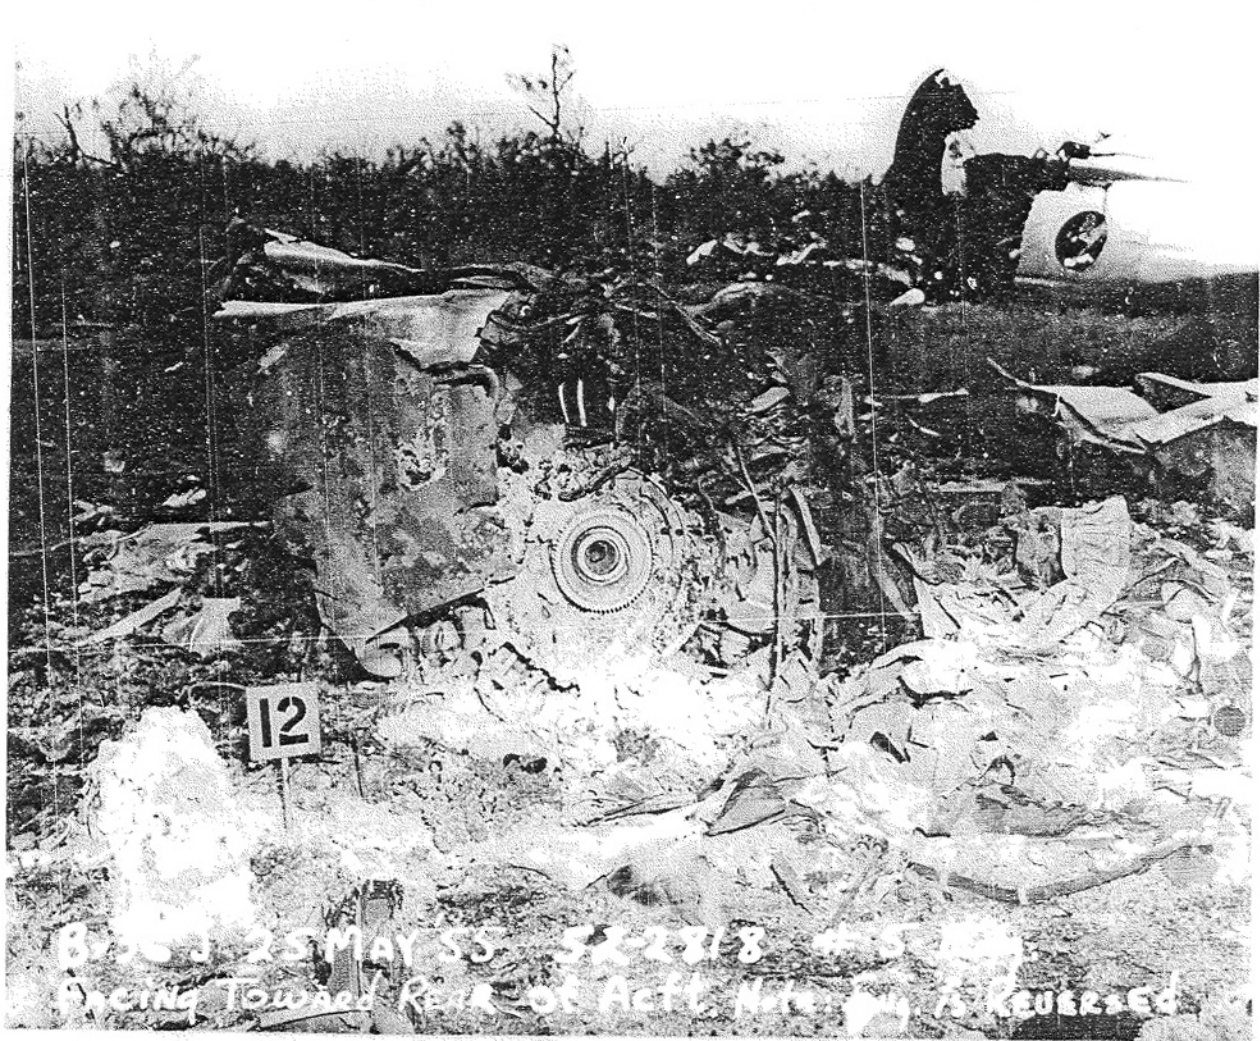
12

B-57J 25 MAY 55 52-2318 #5 JAW
Facing Toward Rear of A/cft. Note Fuel Is Reversed
